GEOTECHNICAL ENGINEERING REPORT

STORMWATER MANAGEMENT AND INFILTRATION TESTING
HAWTHORNE MOUNT POCONO RESORT
PARADISE TOWNSHIP, PA

(Project #22021.2-SWM)

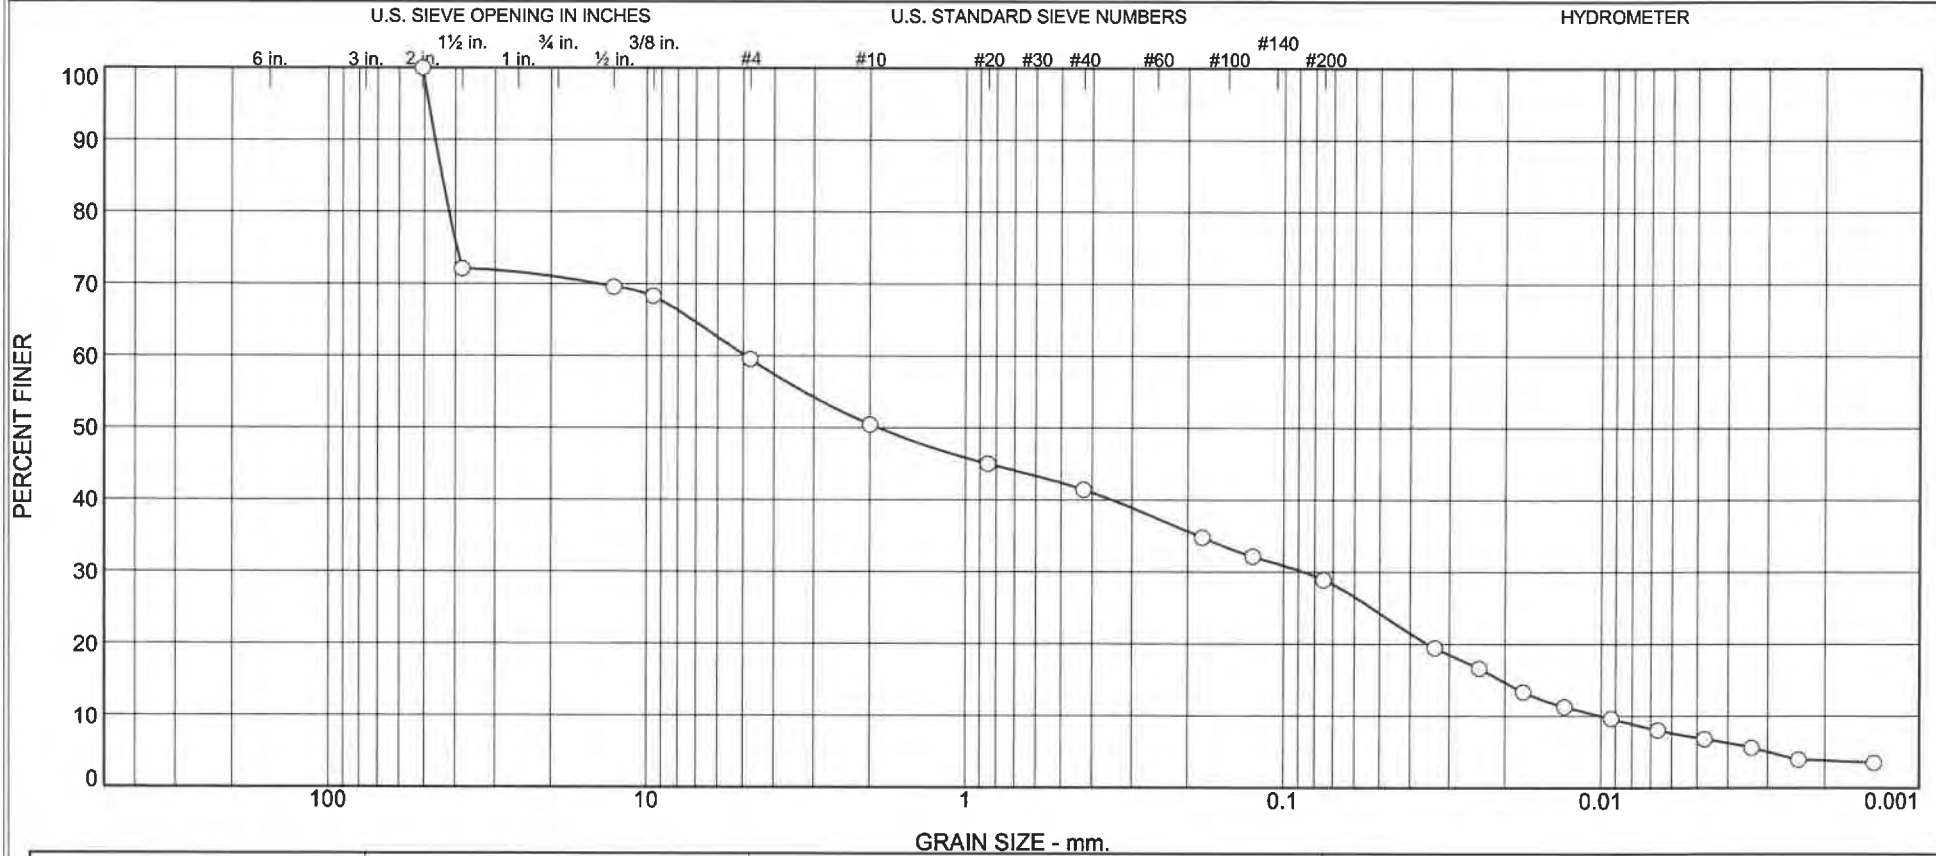
GRADATION AND CLASSIFICATION (ASTM D2487)

% +3"	% Gravel		% Sand			% Fines	
	Coarse	Fine	Coarse	Medium	Fine	Silt	Clay
0.0	29.1	11.4	9.0	9.1	12.5	25.1	3.8

Source	Sample #	Depth/Elev.	Date Sampled	USCS	Material Description	NM %	LL	PL
TP-I-N4	S-1	0.5'/1592.1	2/10/23	GM	red/brown silty GRAVEL with sand Stratum A	12.5	NV	NP

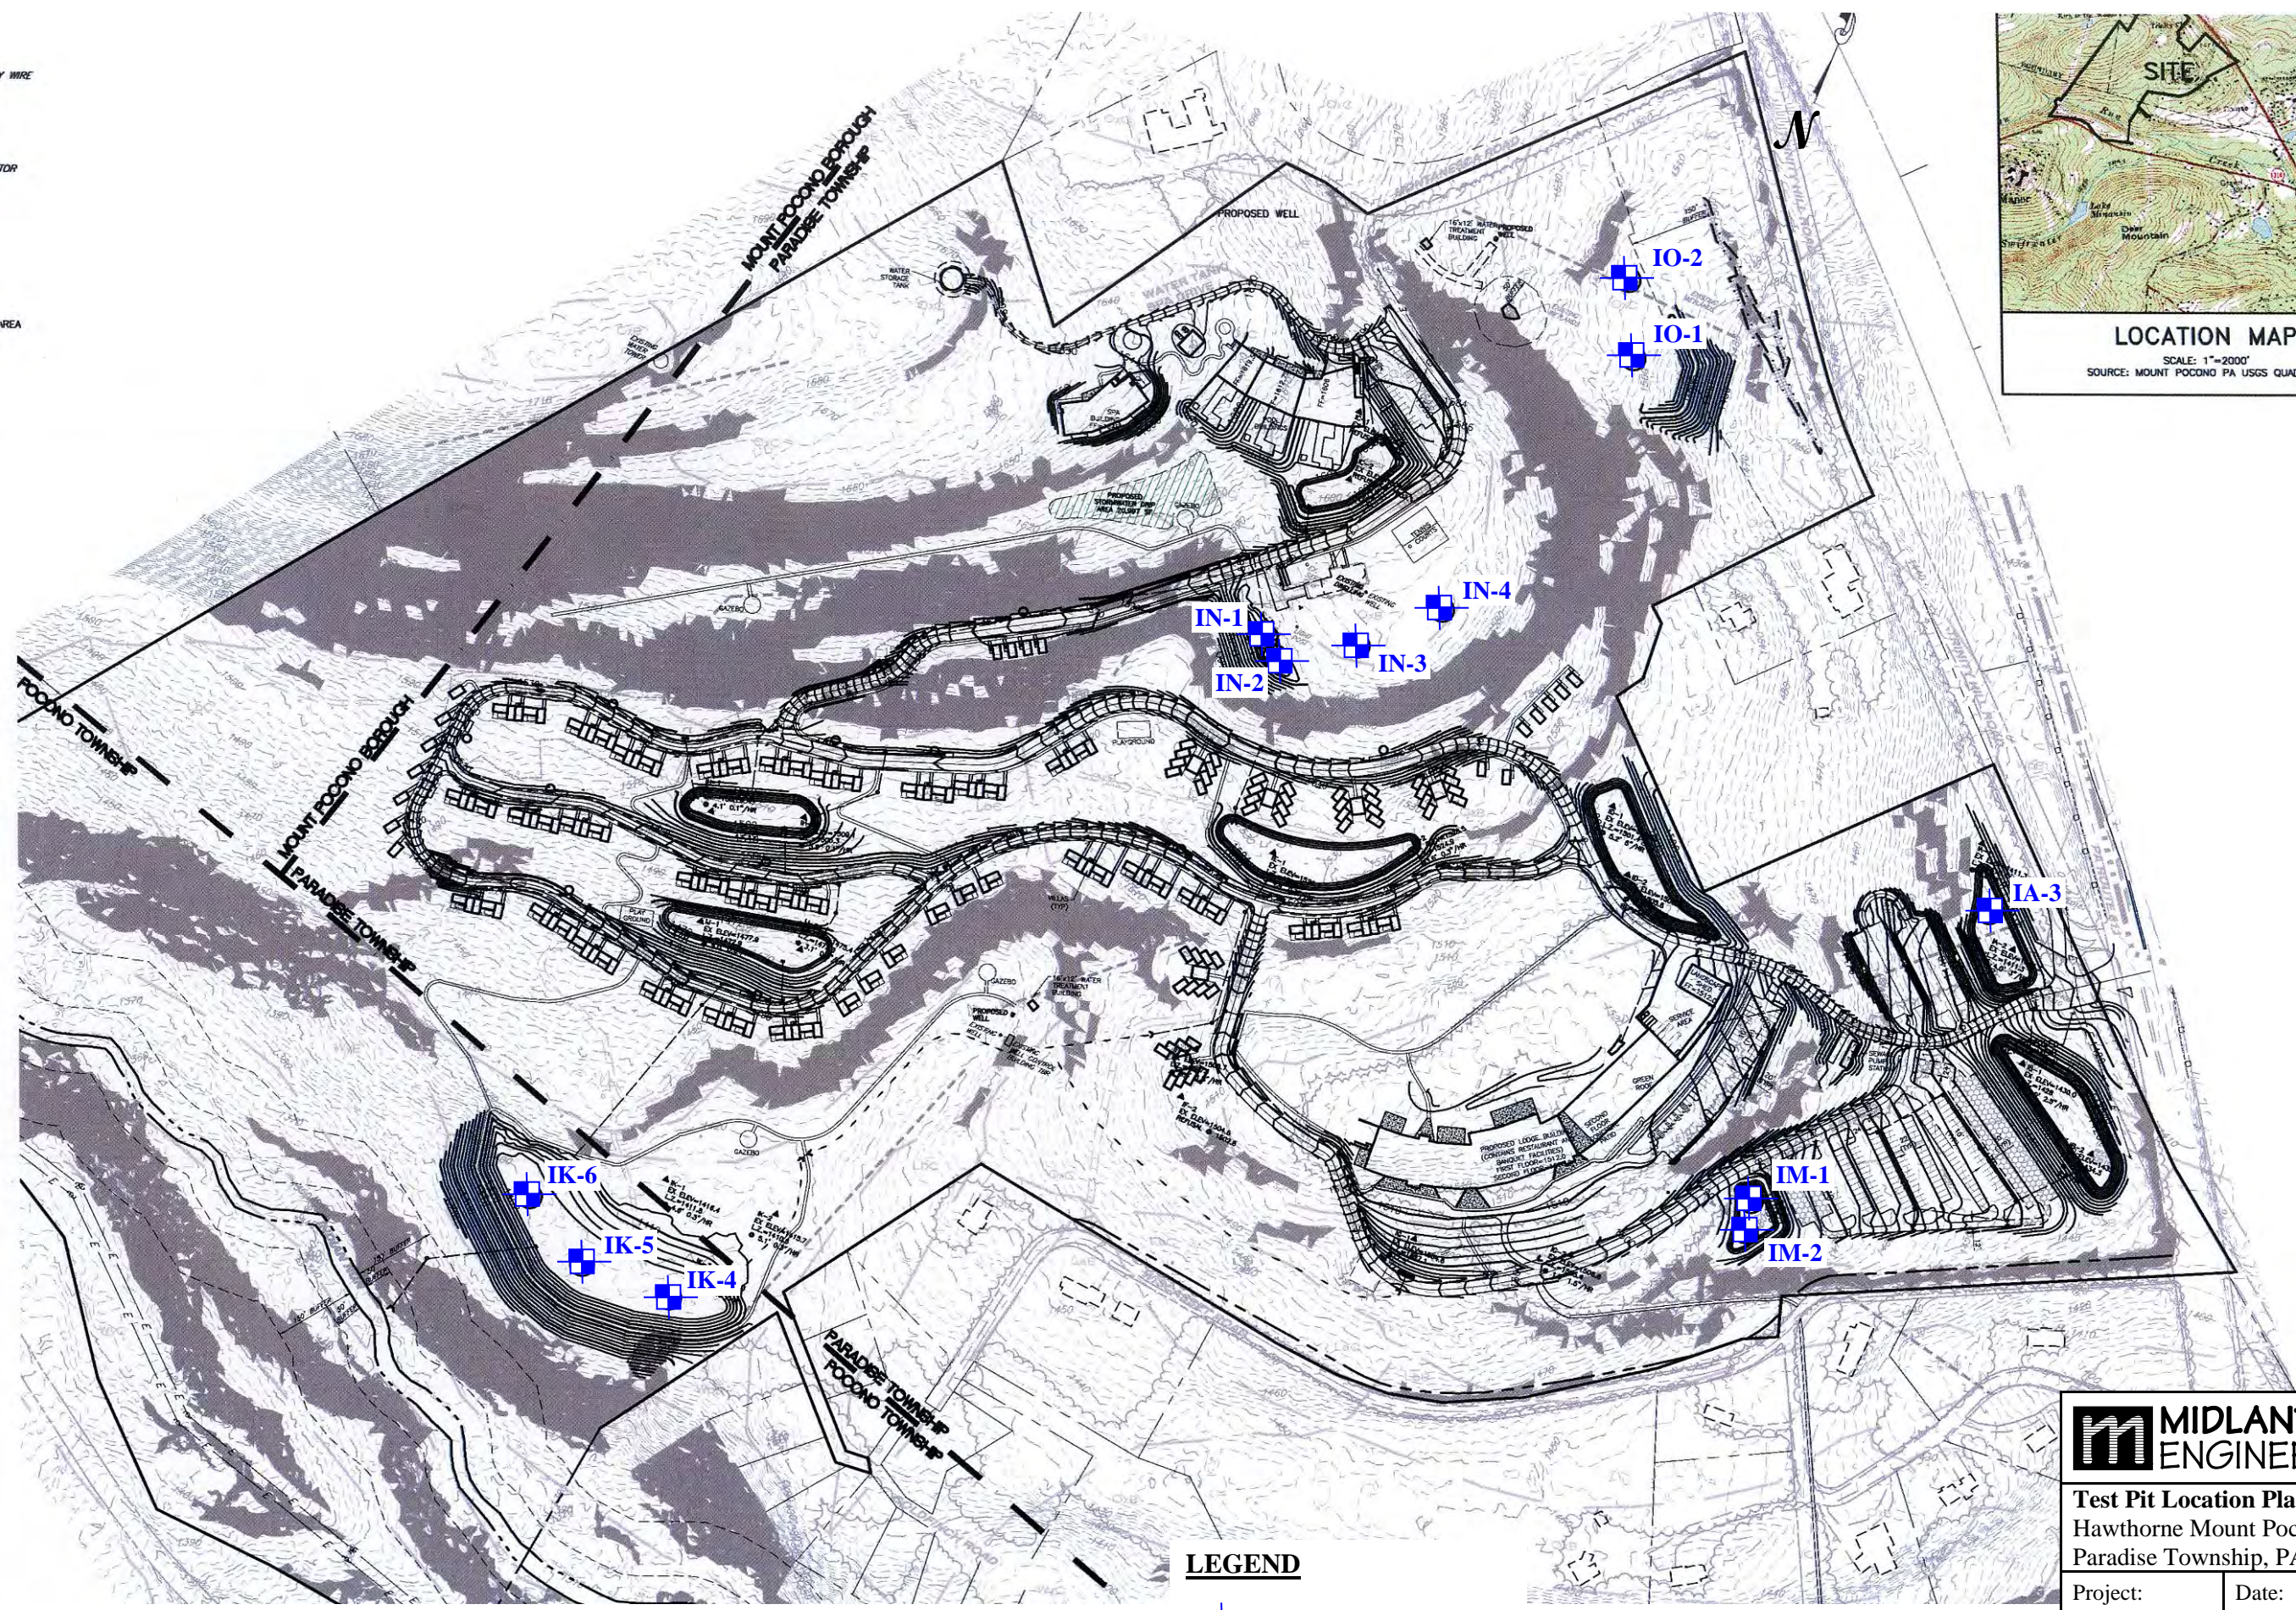
Test Pit Location Plan Hawthorne Mount Pocono Resort Paradise Township, PA		
Project: 22021.2-SWM	Date: 03/03/23	Scale: 1" = 300'

LEGEND
 = Test Pit Location

In order to evaluate subsurface conditions in the proposed stormwater management areas, twelve test pits were excavated on February 9 and 10, 2023. The test pits were extended to depths of 1.5 feet to 14 feet to determine the shallow subsurface stratification and depths to limiting zones, if applicable. The test pit logs, water observation data, and test pit location plan are included in Enclosure (4).

In-situ infiltration testing was conducted at locations indicated on the site plan included in Enclosure (4). The test method referenced in Protocol 1, as summarized herein, was used to conduct the in-situ infiltration testing.

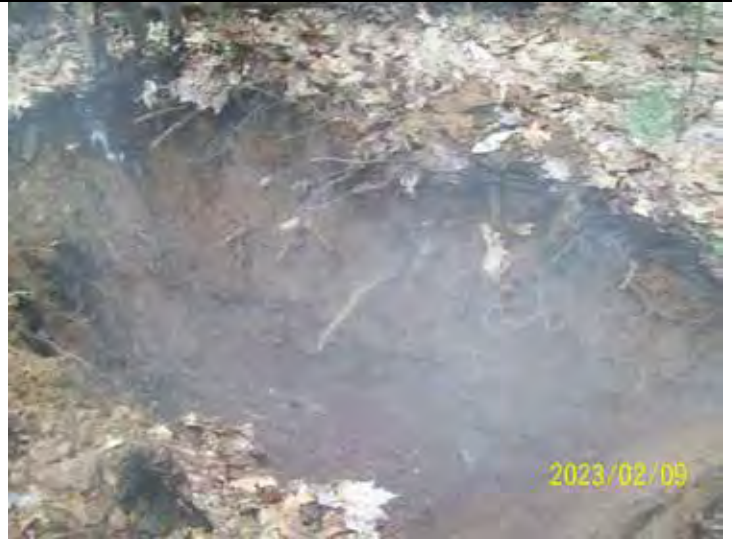
Test Loc. No.: **TP-I-A3**

Depth (ft.)	Strata Description	Class.	Str'm	Elev.	InSitu Testing		M (%)	Remarks
					Depth	Geoprobe Penetr'n		
1	5" topsoil							
2	brown silty SAND with gravel, cobbles	SM	A	1409.7	1		12.2	infiltration testing @ 2.5'; El 1411.7
3					2			
4					3			
5					4			
6	Refusal at 4.5 feet Bottom of Test Pit at 4.5 feet				5			
7					6			
8					7			
9					8			
10					9			
11					10			
12					11			
13					12			
14					13			
15					14

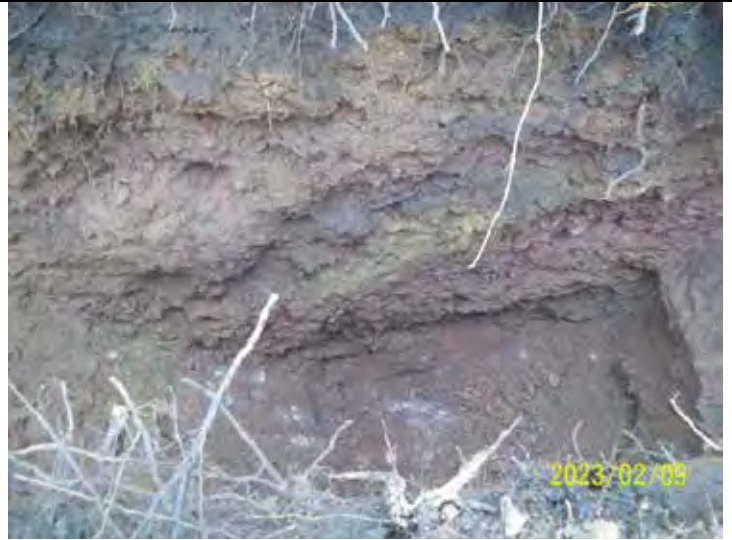
Test Loc. No.: **TP-I-M1**

Depth (ft.)	Strata Description	Class.	Str'm	Elev.	InSitu Testing		M (%)	Remarks
					Depth	Geoprobe Penetr'n		
1	5" topsoil							
1	yellow/brown silty SAND with gravel	SM	A		1		26.8	infiltration testing @ 2.2'; El 1480.3
2								
3								
4								
5	brown silty GRAVEL with sand	GM			5		11.5	infiltration testing @ 8.0'; El 1474.5
6								
7								
10	dark red/brown silty GRAVEL with sand, cobbles				10			
11				1471.0	11			
12	Refusal at 11.5 feet Bottom of Test Pit at 11.5 feet				12			
13								
14								
15

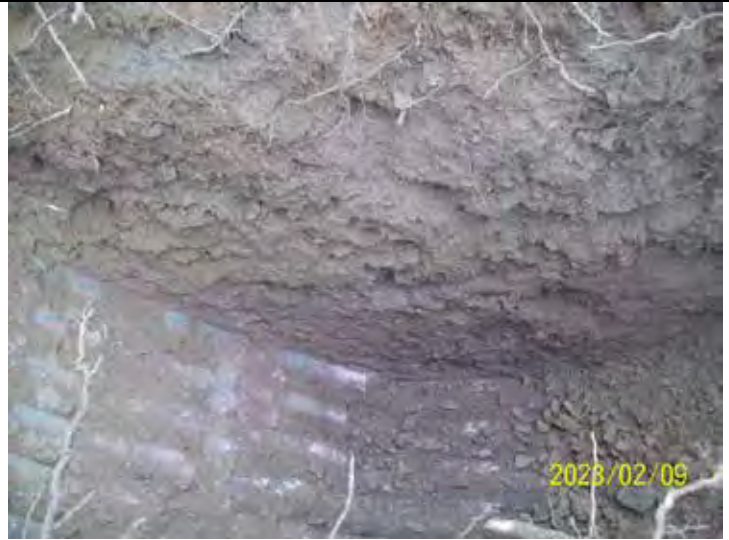
Test Loc. No.: **TP-I-M2**

Depth (ft.)	Strata Description	Class.	Str'm	Elev.	InSitu Testing		M (%)	Remarks
					Depth	Geoprobe Penetr'n		
1	5" topsoil							
1	brown silty sand with gravel - FILL	SM	F		1			
2	@ 2.5': pipe			1480.6	2			
3	brown silty GRAVEL with sand	GM	A		3		7.6	infiltration testing @ 3.1'; El 1480.0
4					4			
5	red/brown silty GRAVEL with sand				5		8.7	infiltration testing @ 5.0'; El 1478.1
6					6			
7				1476.1	7			
8	Refusal at 7.0 feet Bottom of Test Pit at 7.0 feet				8			
9					9			
10					10			
11					11			
12					12			
13					13			
14					14			
15					15

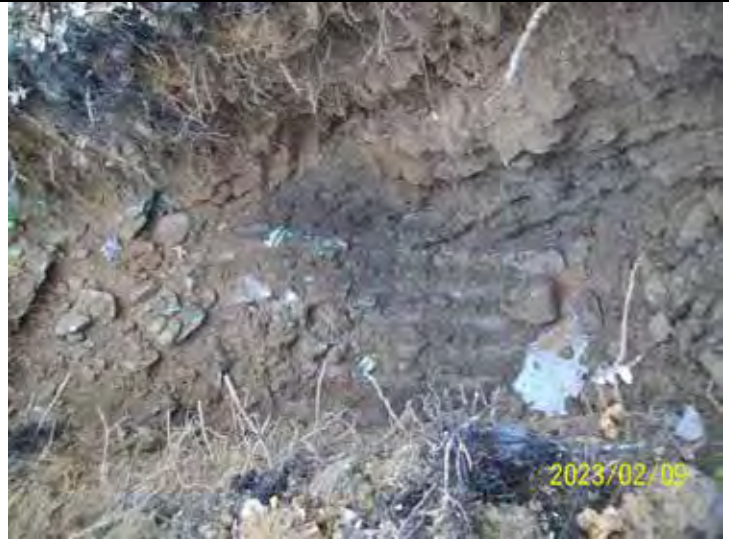
Test Loc. No.: **TP-I-K4**

Depth (ft.)	Strata Description	Class.	Str'm	Elev.	InSitu Testing		M (%)	Remarks
					Depth	Geoprobe Penetr'n		
1	5" topsoil							
2	brown well graded GRAVEL with silt and sand	GW-GM	A		1		6.7	infiltration testing @ 5.1'; El 1402.0
3					2			
4					3			
5					4			
6					5			
7								
8	@ 7.5': gray mottling			1398.6	8			
9	Bottom of Test Pit at 8.5 feet				9			
10					10			
11					11			
12					12			
13					13			
14					14			
15					15

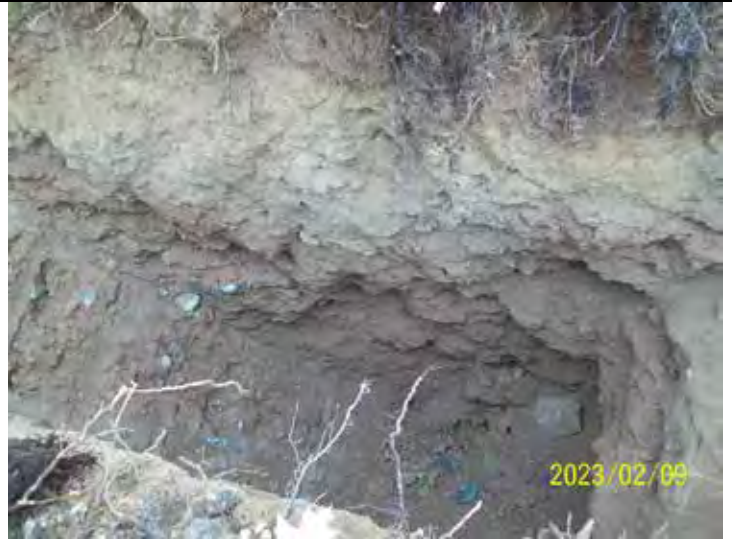
Test Loc. No.: **TP-I-K5**

Depth (ft.)	Strata Description	Class.	Str'm	Elev.	InSitu Testing		M (%)	Remarks		
					Depth	Geoprobe Penetr'n				
1	6" topsoil									
2	yellow/brown well graded GRAVEL with silt and sand	GW-GM	A				6.5	infiltration testing @ 2.9'; El 1402.0		
3										
4	brown silty GRAVEL with sand	GM						7.7		
5										
6										
7										
8										
9										
10										
11										
12										
13										
14	Bottom of Test Pit at 14.0 feet			1390.9						
15

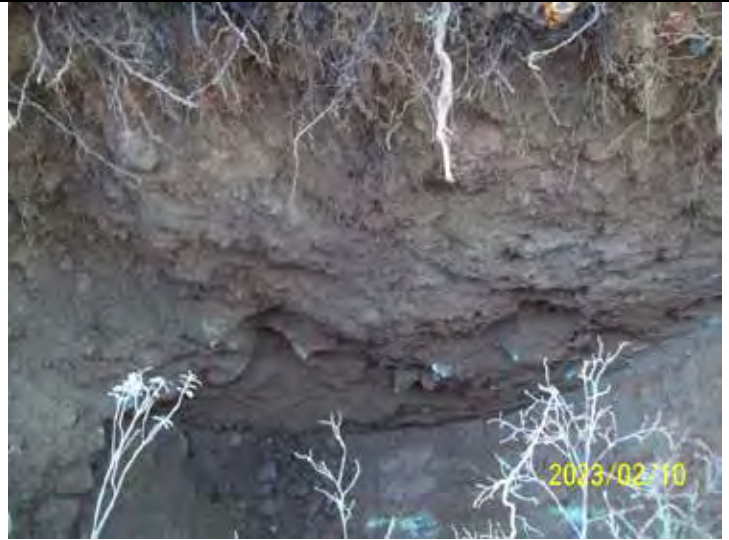
Test Loc. No.: **TP-I-K6**

Depth (ft.)	Strata Description	Class.	Str'm	Elev.	InSitu Testing		M (%)	Remarks
					Depth	Geoprobe Penetr'n		
1	5" topsoil							
1	brown silty GRAVEL with sand	GM	A		1		11.4	infiltration testing @ 2.0'; El 1398.3
2					2			
3					3			
4					4			
5	brown well graded GRAVEL with silt and sand	GW-GM			5		18.5	infiltration testing @ 8.0'; El 1392.3
6					6			
6	@ 6'-10': cobbles				7			
8					8			
9					9			
10	Bottom of Test Pit at 10.0 feet			1390.3	10			
11					11			
12					12			
13					13			
14					14			
15					15

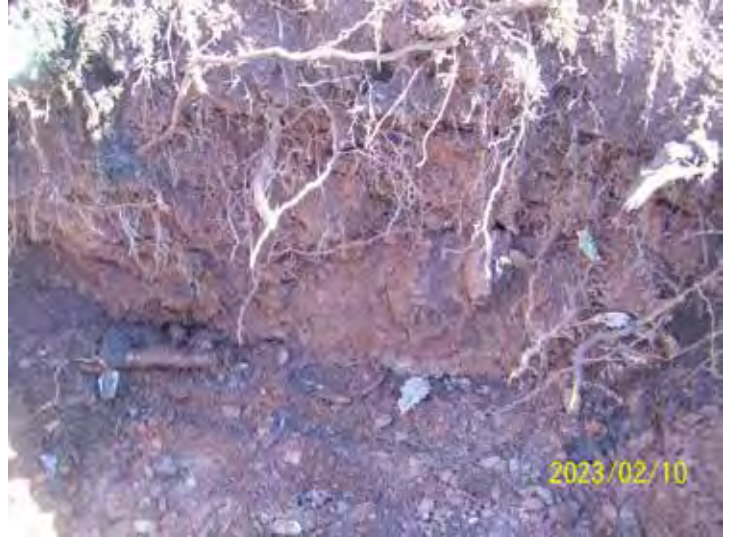
Test Loc. No.: **TP-I-N1**

Depth (ft.)	Strata Description	Class.	Str'm	Elev.	InSitu Testing		M (%)	Remarks
					Depth	Geoprobe Penetr'n		
1	6" topsoil							
2	red/brown silty GRAVEL with sand	GM	A	1571.2	1		14.0	infiltration testing @ 1.5'; El 1573.2
3					2			
4					3			
4	Refusal at 3.5 feet Bottom of Test Pit at 3.5 feet				4			
5					5			
6					6			
7					7			
8					8			
9					9			
10					10			
11					11			
12					12			
13					13			
14					14			
15					15

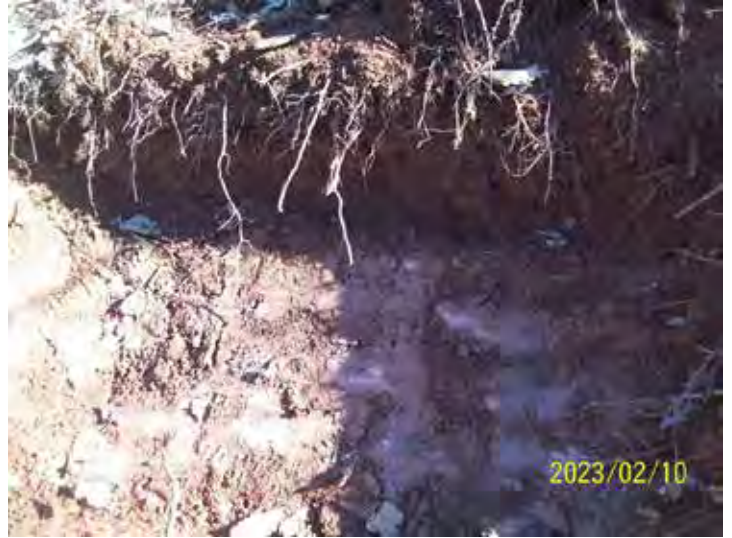
Test Loc. No.: **TP-I-N2**

Depth (ft.)	Strata Description	Class.	Str'm	Elev.	InSitu Testing		M (%)	Remarks
					Depth	Geoprobe Penetr'n		
1	3" topsoil red/brown silty GRAVEL with sand	GM	A	1571.3	1			No infiltration testing performed – insufficient depth to limiting zone.
2	Refusal at 1.5 feet Bottom of Test Pit at 1.5 feet				2			
3					3			
4					4			
5					5			
6					6			
7					7			
8					8			
9					9			
10					10			
11					11			
12					12			
13					13			
14					14			
15					15

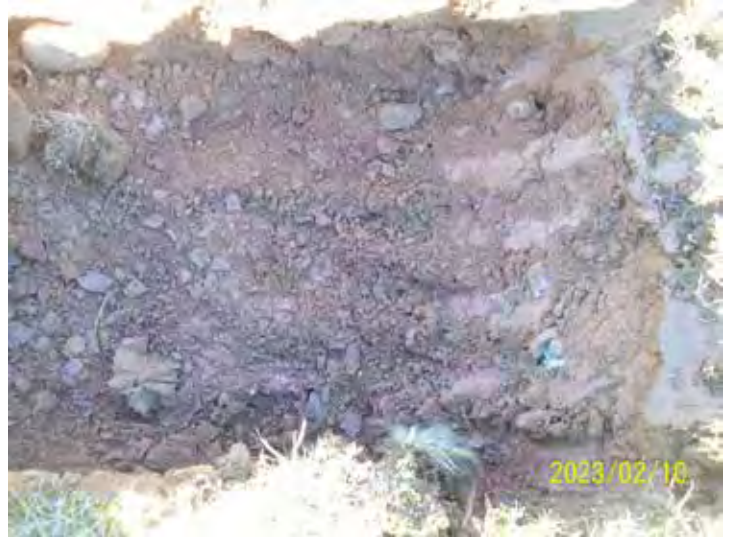
Test Loc. No.: **TP-I-N3**

Depth (ft.)	Strata Description	Class.	Str'm	Elev.	InSitu Testing		M (%)	Remarks
					Depth	Geoprobe Penetr'n		
1	1" topsoil						27.9	infiltration testing @ 0.5'; El 1587.0
1	red/brown silty SAND with gravel	SM	A		1			
2				1585.0	2			
3	Refusal at 2.5 feet Bottom of Test Pit at 2.5 feet				3			
4					4			
5					5			
6					6			
7					7			
8					8			
9					9			
10					10			
11					11			
12					12			
13					13			
14					14			
15					15

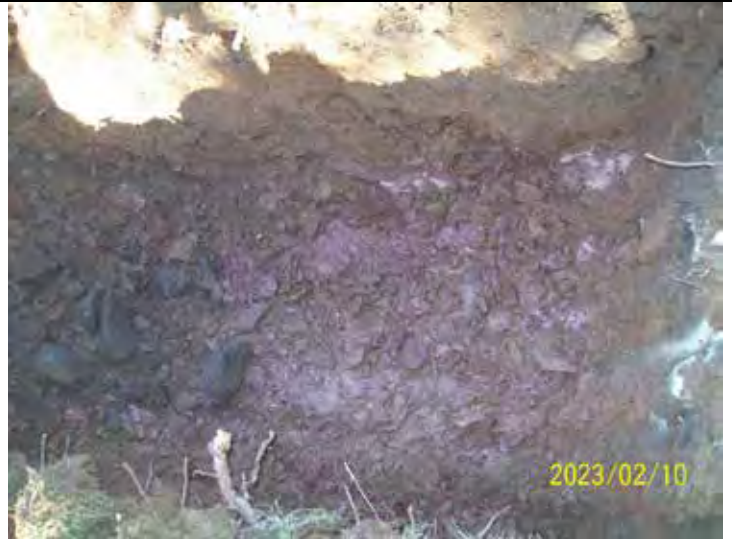
Test Loc. No.: **TP-I-N4**

Depth (ft.)	Strata Description	Class.	Str'm	Elev.	InSitu Testing		M (%)	Remarks
					Depth	Geoprobe Penetr'n		
1	1" topsoil						12.5	infiltration testing @ 0.5'; El 1592.1
2	red/brown silty GRAVEL with sand	GM	A	1590.1				
3	Refusal at 2.5 feet Bottom of Test Pit at 2.5 feet							
4								
5								
6								
7								
8								
9								
10								
11								
12								
13								
14								
15

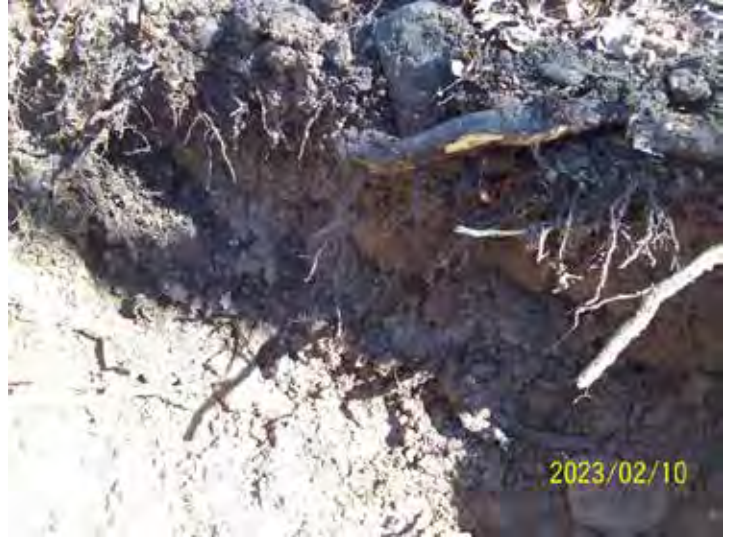
Test Loc. No.: **TP-I-01**

Depth (ft.)	Strata Description	Class.	Str'm	Elev.	InSitu Testing		M (%)	Remarks
					Depth	Geoprobe Penetr'n		
1	9" topsoil							
1	gray/orange silty SAND with gravel @ 1.5': mottling	SM	A	1501.7	1		13.2	No infiltration testing conducted due to depth of groundwater at 1.5'.
2					2			
3					3			
4	Bottom of Test Pit at 3.5 feet				4			
5					5			
6					6			
7					7			
8					8			
9					9			
10					10			
11					11			
12					12			
13					13			
14					14			
15					15

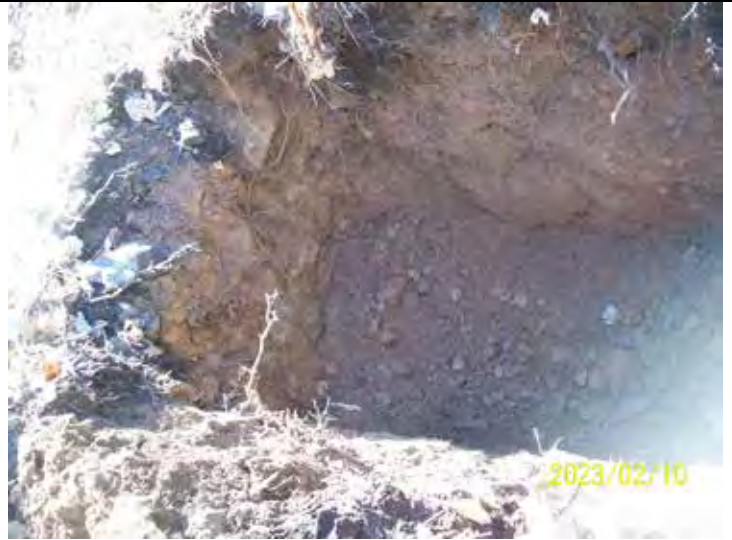
Test Loc. No.: **TP-I-02**

Depth (ft.)	Strata Description	Class.	Str'm	Elev.	InSitu Testing		M (%)	Remarks
					Depth	Geoprobe Penetr'n		
1	5" topsoil							
1	brown silty SAND with gravel @ 3.5': mottling	SM	A	1499.8	1		18.6	infiltration testing @ 1.5'; El 1503.3
2					2			
3					3			
4					4		11.8	
5	Bottom of Test Pit at 5.0 feet				5			
6					6			
7					7			
8					8			photo of mottling @ 3.5'
9					9			
10					10			
11					11			
12					12			
13					13			
14					14			
15					15
